# Crack Detection for Aerospace Quality Spur Gears

Harry J. Decker

U.S. Army Research Laboratory, Glenn Research Center, Cleveland, Ohio

Prepared for the  
International 58th Annual Forum and Technology Display  
sponsored by the American Helicopter Society  
Montreal, Quebec, Canada, June 11–13, 2002

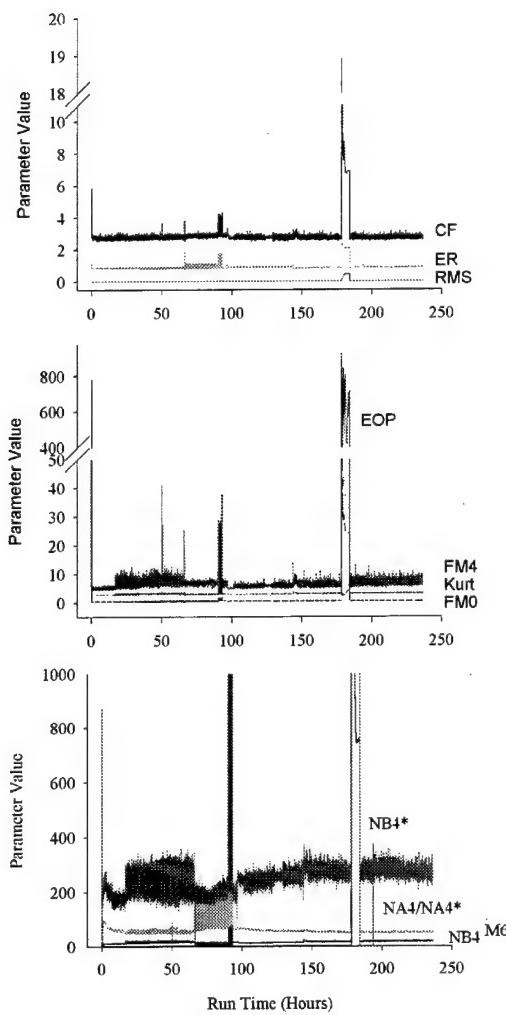
Figure 6. Test 1, case accelerometer parameters

Figure 6 also shows the results of when the facility accelerometer lost power and shut the facility down (approximately 70 hours), and an unexplained set of conditions at about 170 hours. Experience has shown that several of the diagnostic parameters take a significant amount of time to settle back into steady state like conditions after an interruption, if at all. It is important to note the amplitude of these disturbances for comparison later on. It is proposed that during a shutdown, the temperature decrease changes the system dynamics by altering the clearances and contact stresses from the previous conditions. In this figure there is no obvious indication of crack initiation, progression or separation of the gear tooth.

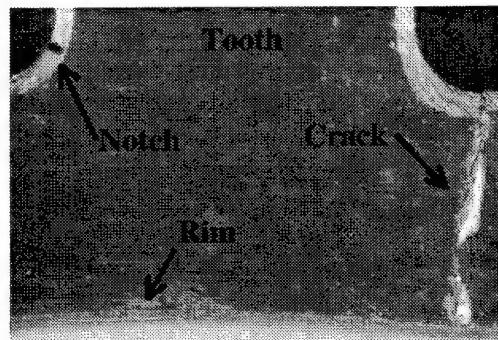
Figure 7. Gear rim fracture after test 2

Test 2 was conducted at 5000 rpm and 154.6 Nm (114 ft-lbs) torque. This test ended at 1.7 hours with a fracture through the rim (Figure 7), which may have been caused by running near a gear resonance. At 1.4 hours, high vibration levels caused a test shutdown. The gear was examined and a mark taken to be dirt or fuzz was noticed. This may have actually been the crack that eventually propagated through the rim. The notch can be seen in the upper left corner of Figure 7.

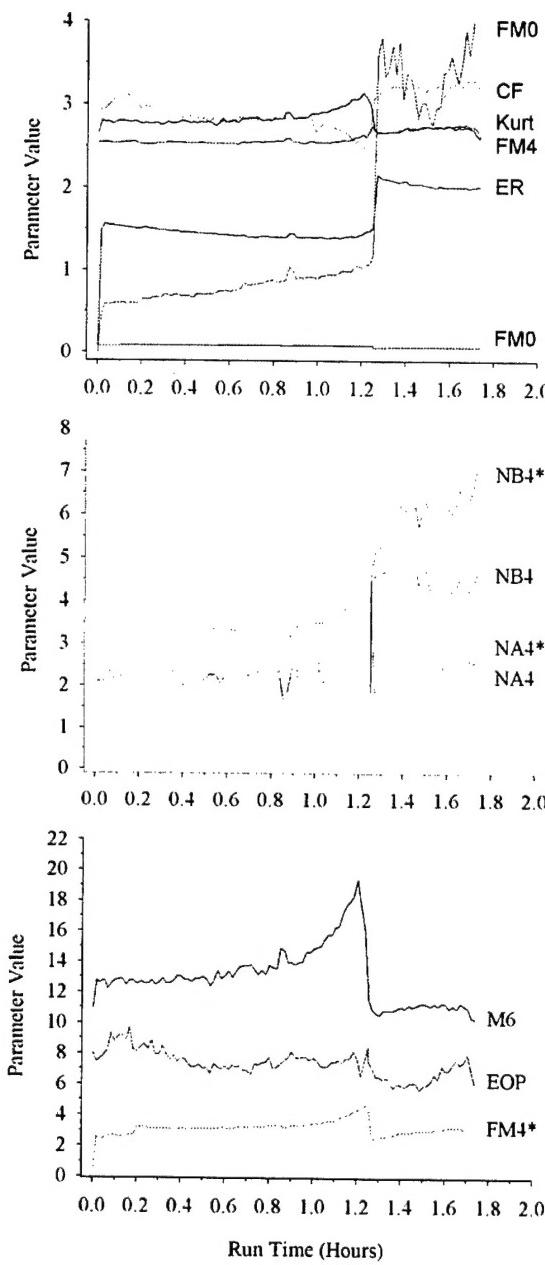
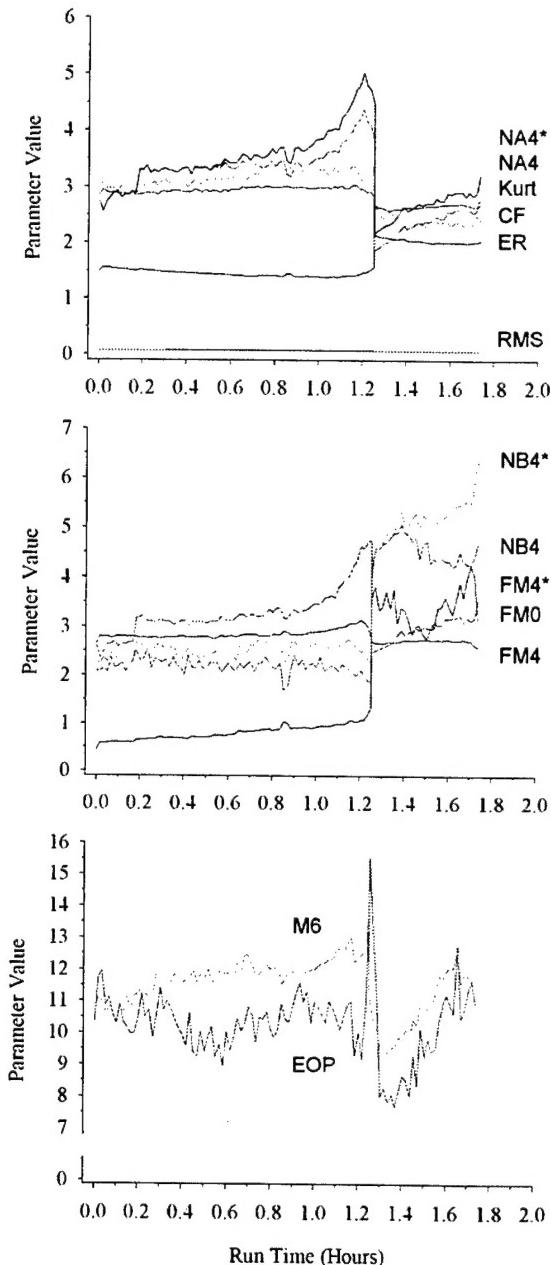
Figures 8 and 9 present the results of applying these parameters to the vibration recorded by the two accelerometers. In this test, almost all of the techniques examined indicate something at 1.25 hours. The variations due to the shutdown and subsequent startup are readily visible.

The ideal parameter would show a step change at initiation of damage, a linear increase during damage progression with another step increase to a high level to indicate the loss of the tooth for the remainder of the run. The M6 parameter demonstrates one of the deficiencies of several of the parameters. Some of the parameters after increasing to indicate damage, reduce in value as the damage becomes more distributed. If the peak is not detected, there is a very real possibility of encountering a Type I error. The results of the NB4\* parameter, at least in this test, demonstrates the desired characteristics of a robust parameter.

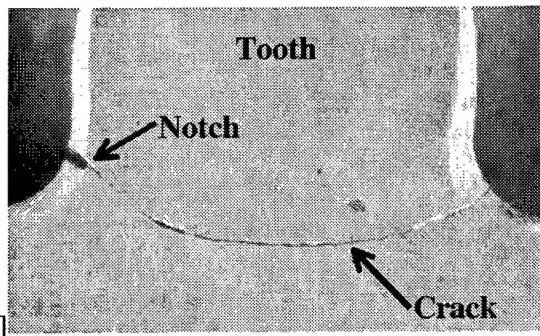
Figure 10. Gear tooth fracture after test 3

This test also produced a fractured tooth (Figure 10). This fracture was not complete and progressed about two-thirds of the width of the tooth. The facility monitoring accelerometer detected a high vibration level due to the crack and shut down the system before the loss of the tooth. The shutdown occurred after almost 420 hours of 4925 rpm at torques of 124.7, 139.4, and 154.6 Nm (92, 106, and 114 ft-lbs) of torque. The gear was then later run at various torques until complete fracture occurred.

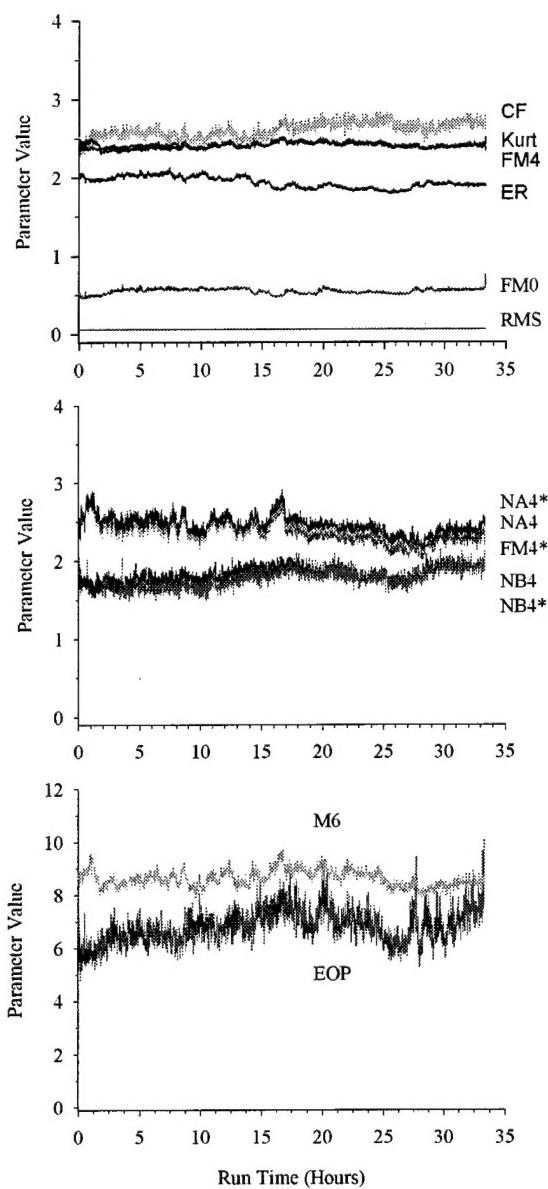
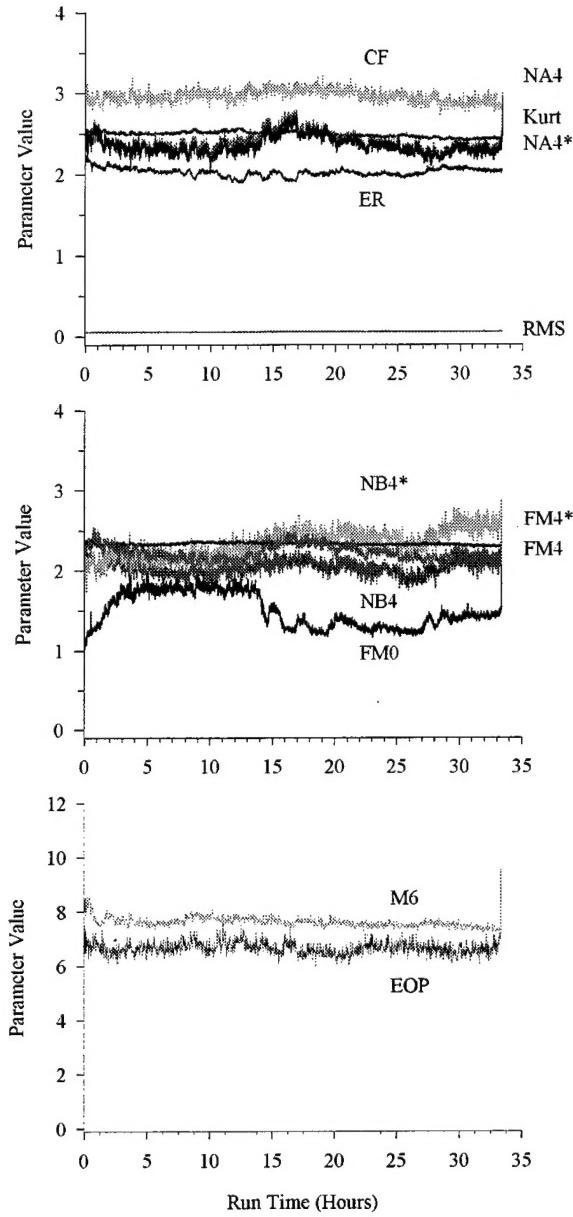
As seen in Figure 11 and Figure 12, the widely used parameters do not readily indicate any crack initiation or propagation. The last 3 points of FM0 in Figure 11 and NA4 and FM0 in Figure 12, with their abrupt increase in value, may hint at the damage. In this case, the shaft mounted accelerometer, with its shorter and more direct transfer path indicates the damage better
